Altronic Service Bulletin #519

ISSUED: 6/8/18

Flex Panel PCB

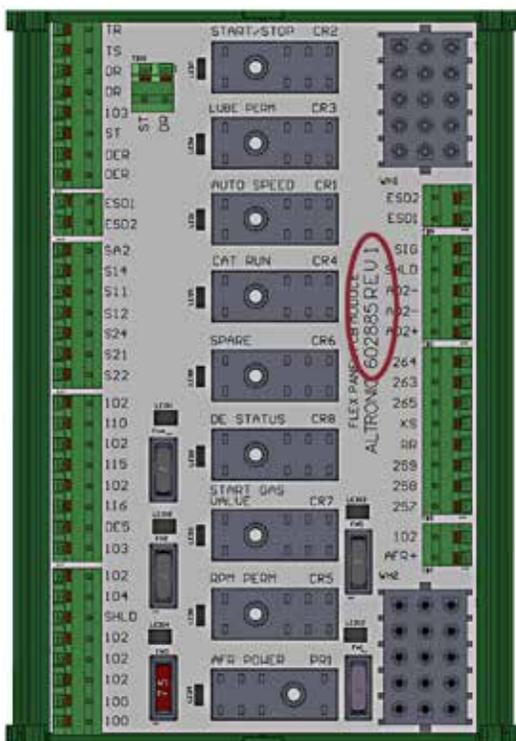
Any Flex Panel PCB (part number 691763) Revision 0 and Revision 1.

Refer to the picture below. The board will have a board part number on it 602885 followed by a revision number. Any board with a revision number "0" or "1" is affected.

An issue has been identified where incorrect operation of the panel light on the Caterpillar 3300B MIDS panel has been identified. This incorrect operation does not damage any components, nor does it affect the normal day-to-day operation of the systems. This occurs when a powered MIDS panel is connected to an unpowered Flex Panel PCB via the KS and RR terminals. In this condition the signal at the RR terminal causes the green "Run light" on the MIDS panel to incorrectly illuminate.

1. For all current panels in the field exhibiting the described condition Altronic will provide, upon request, a diode terminal block. This terminal block can easily be installed by snapping it onto the DIN rail in the panel and connecting the two wires.
